# DESIGN GUIDELINES MANUAL

### SOUTH END BUSINESS OVERLAY DISTRICT

The City of Tybee Island  
Chatham County, Georgia

September 2019

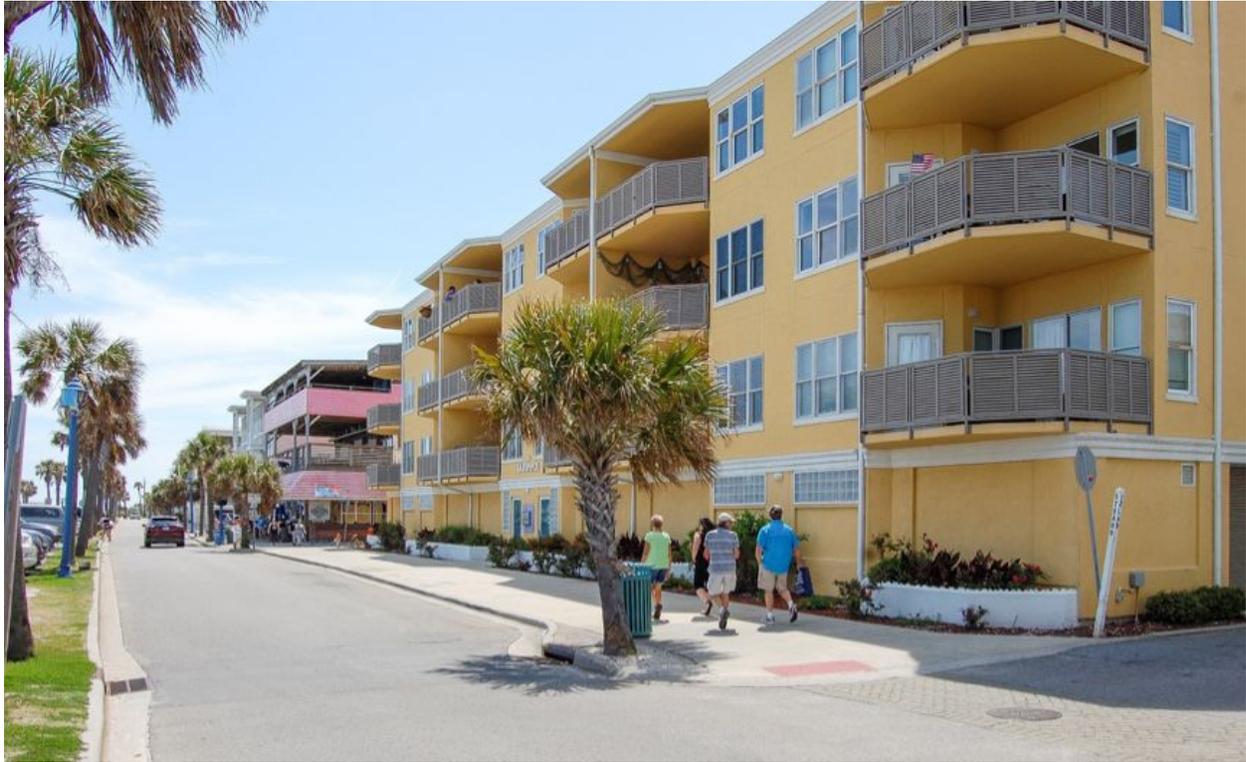
**Figure 3.** View of newer multi-family buildings on the Strand with blank walls along the street. The restaurant in the background features numerous porches and an active ground-floor use resulting in a heavier pedestrian presence.

A variety of uses, building types, materials and architectural expressions are found throughout the district. Street presence, or the location and orientation of buildings and structures along the street, as well as architectural features were identified in each of these locations. Active first floor uses and storefronts are important features of the commercial streets in the South End. Where pools or large spans of solid wall existed without a business activity, there was less pedestrian presence (Figure 3).

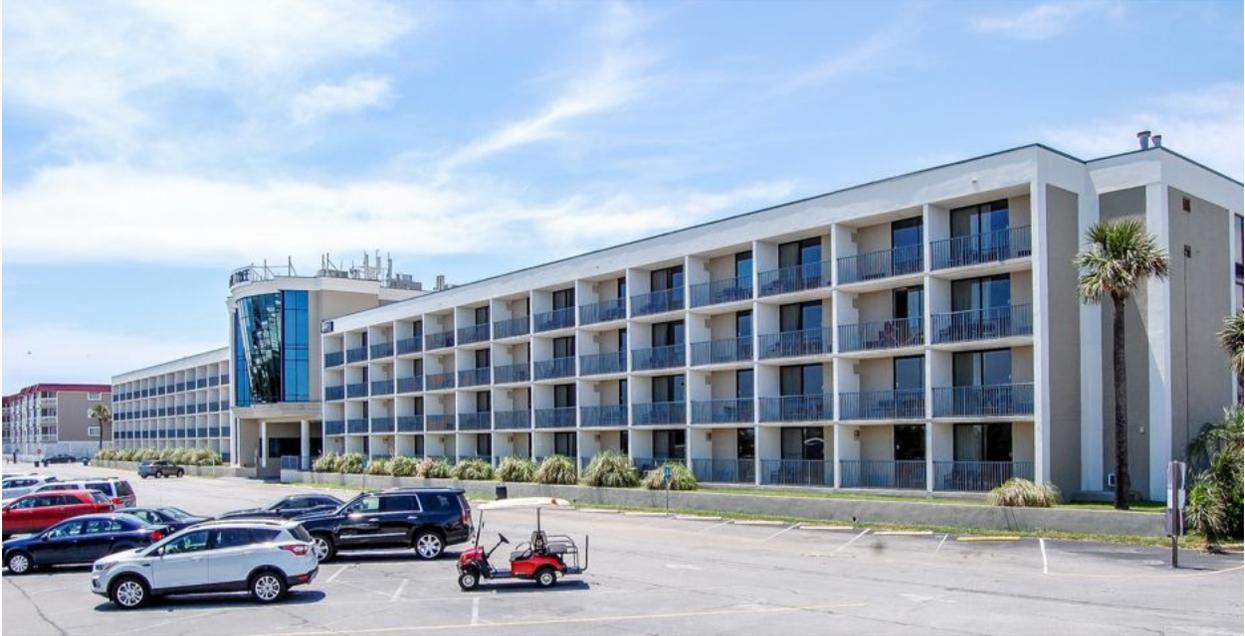
**Figure 4.** The Tybee Hotel on the Strand, looking southwest from walkway to beach.

Commonalities were found in both commercial and residential areas. The location of trash receptacles and mechanical equipment was clearly visible throughout the district due to visibility of most facades from the public right-of-way. Large commercial or multi-family structures were built to the 35-foot height limit resulting in buildings with large footprints, flat roofs and usually a large area of wall space with no openings along the street (Figure 4).

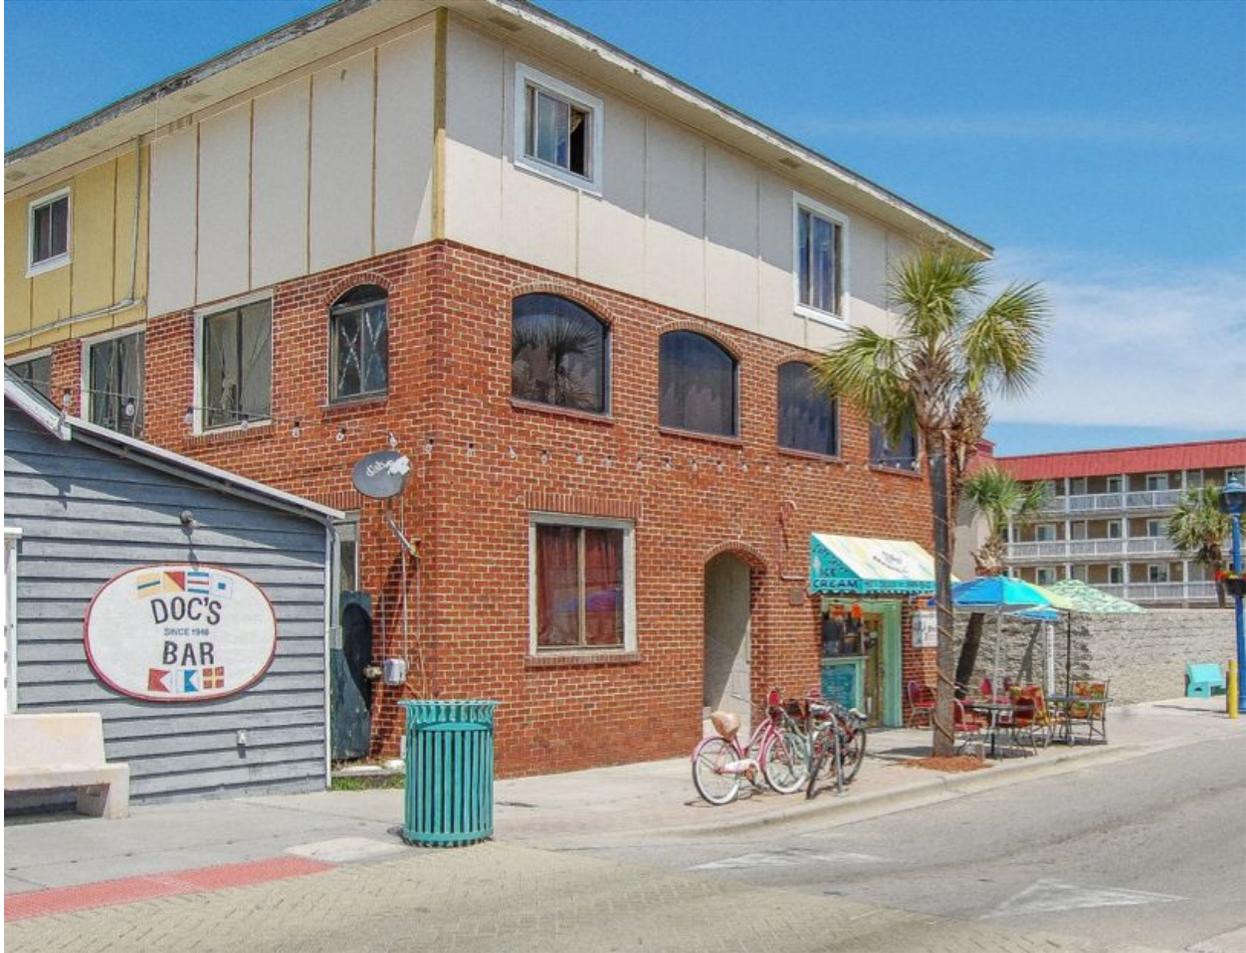
**Figure 6.** This building along Tybrisa, which is over 50 years of age, was added onto over time altering its original appearance in a manner that impacts its integrity and the surrounding context, placing a three-story building next to a smaller one-story structure.

structures (Figure 6), replacement windows, and porch infill. These alterations had the ability to change the character of the building over time creating a larger mass, flattening the façade, and in some cases making it difficult to determine if the building was over 50 years of age. Most vacant properties and some rear facades of operating businesses were boarded where not currently active.

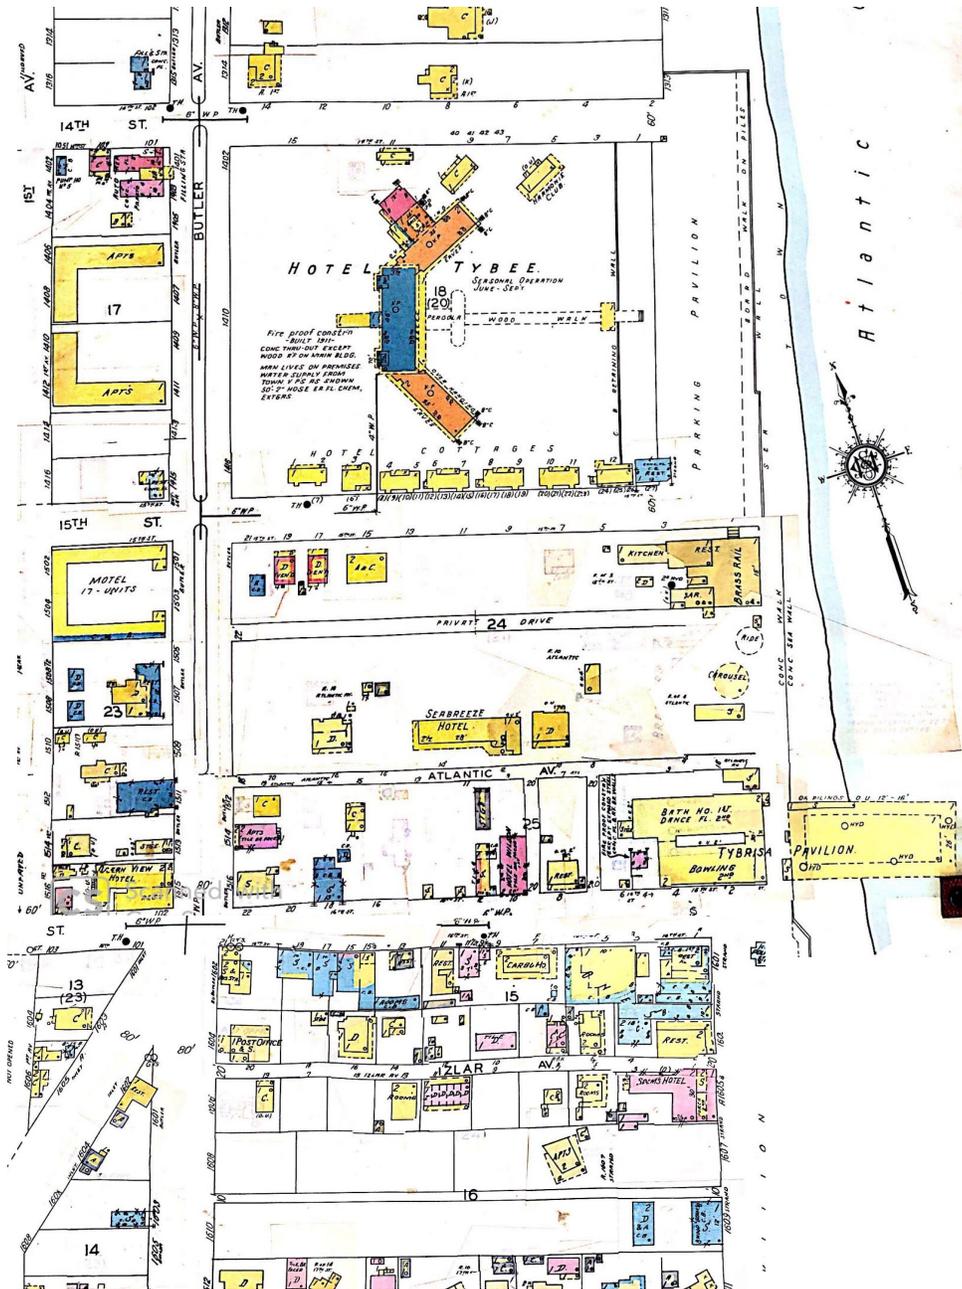
**Figure 10.** 1916 Sanborn Fire Insurance Map, Tybee Section published 1937 and revised through 1952, showing the development of wood frame cottages along Izlar Avenue following the devastating fire that destroyed all previous buildings shown on the 1916 Map in Figure 3 (Sanborn Map Company).

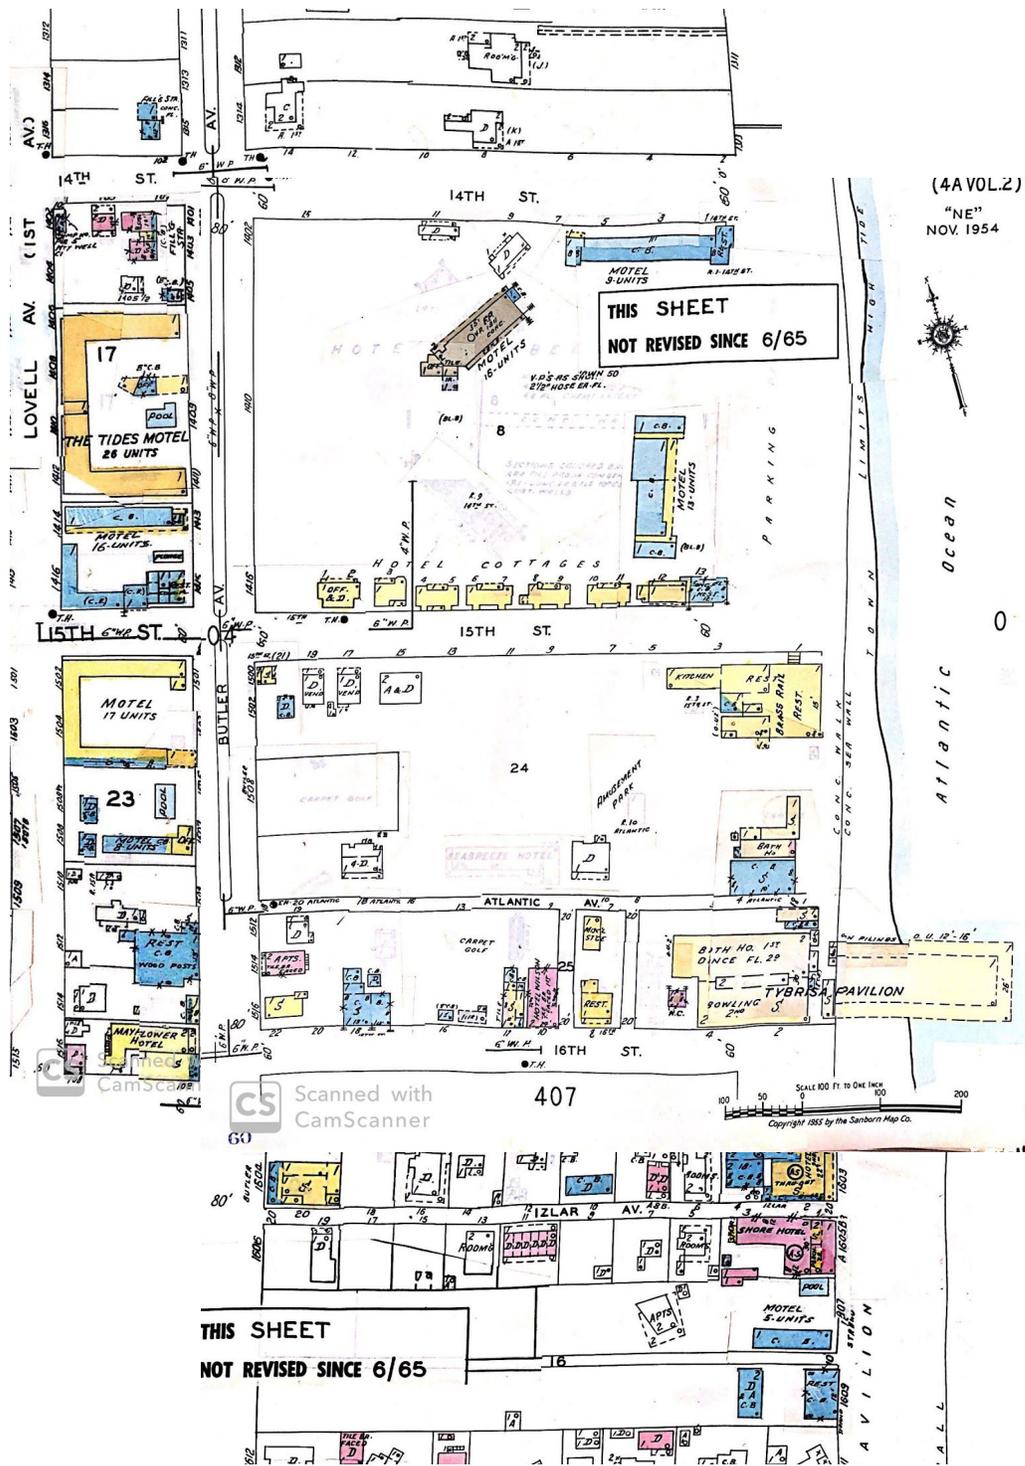
Figure 11. 1955 Sanborn Fire Insurance Map, Tybee section revised through 1965 (Sanborn Map Company).

The 1955 Sanborn Map was revised through 1965 showing increased development within the area during this period (Figure 11). An aerial view looking west over the resort area of the island shows the development of the area ca.1958 (Figure 12).

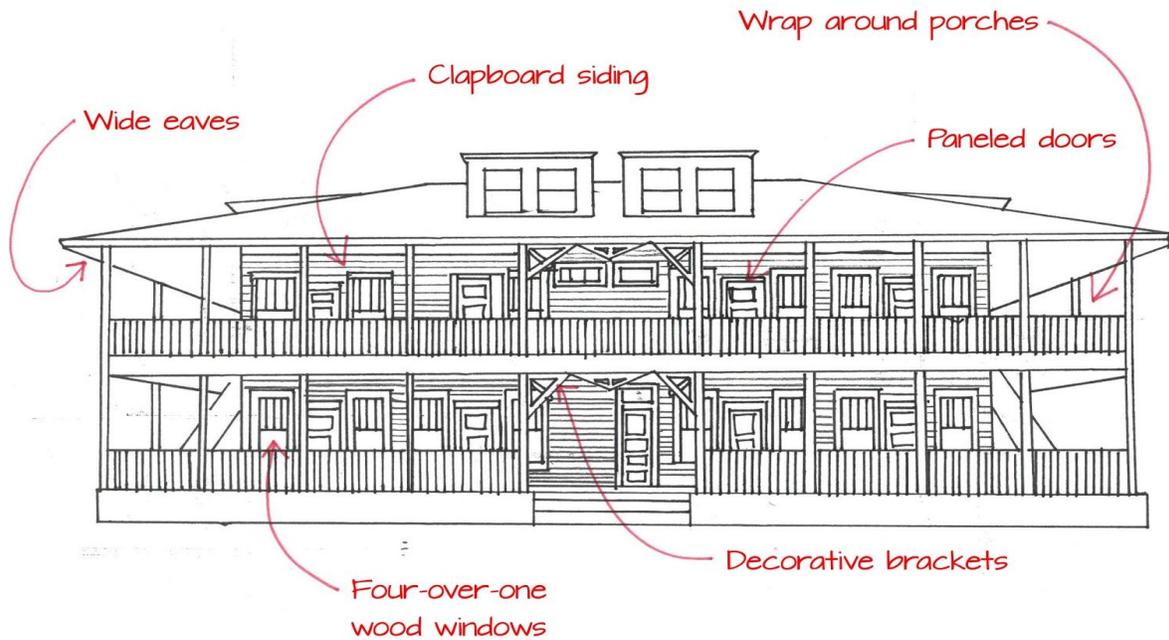
**Figure 14.** Character-defining features of the circa 1932 Carbo House at 9 Tybrisa Street.

Character-defining features include the overall shape of a building, its materials, craftsmanship, and decorative details, as well as aspects of its site and environment (Figure 14). The building can then be examined through two lenses, type and style. Building type is generally defined by the floor plan and height. Building or architectural style is the ornament or decoration of a building. These two subsets are further defined in the [City of Tybee Island Historic Resources Survey Phase I](#).

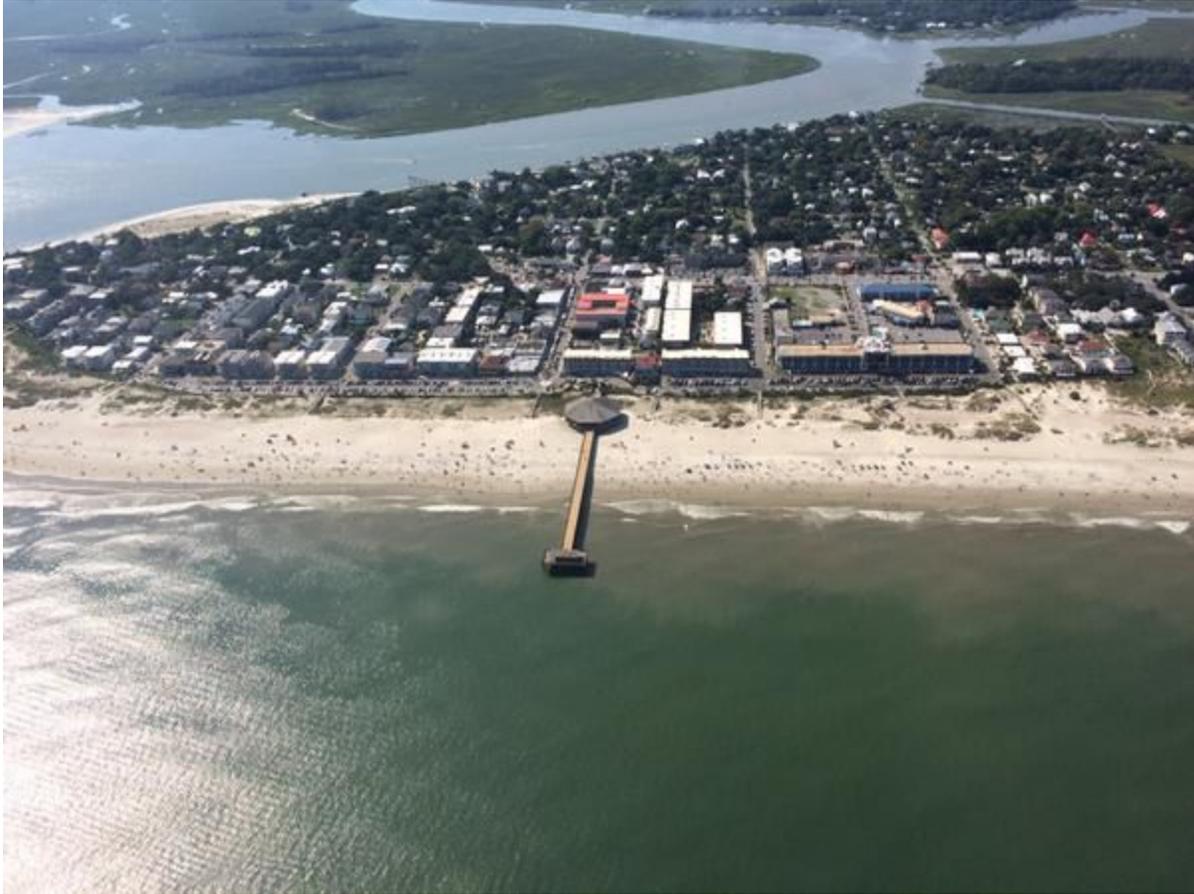
**Figure 15.** Aerial view from 2014 of the South End area looking west, showcasing the 35 foot height limit for construction (Photo courtesy of Visit Tybee).

Early twentieth century development features varied rooflines to include front and side gable roofs, hip roofs, and flat roofs with parapets. Both asphalt shingles and standing seam metal roofs are commonly found on historic buildings both historically and today. More recent construction has been varied and incongruous, largely consisting of buildings with flat roofs with parapets or pent roofing along the ridgeline, maximizing internal square footage while meeting the 35 foot height limit (Figure 15).

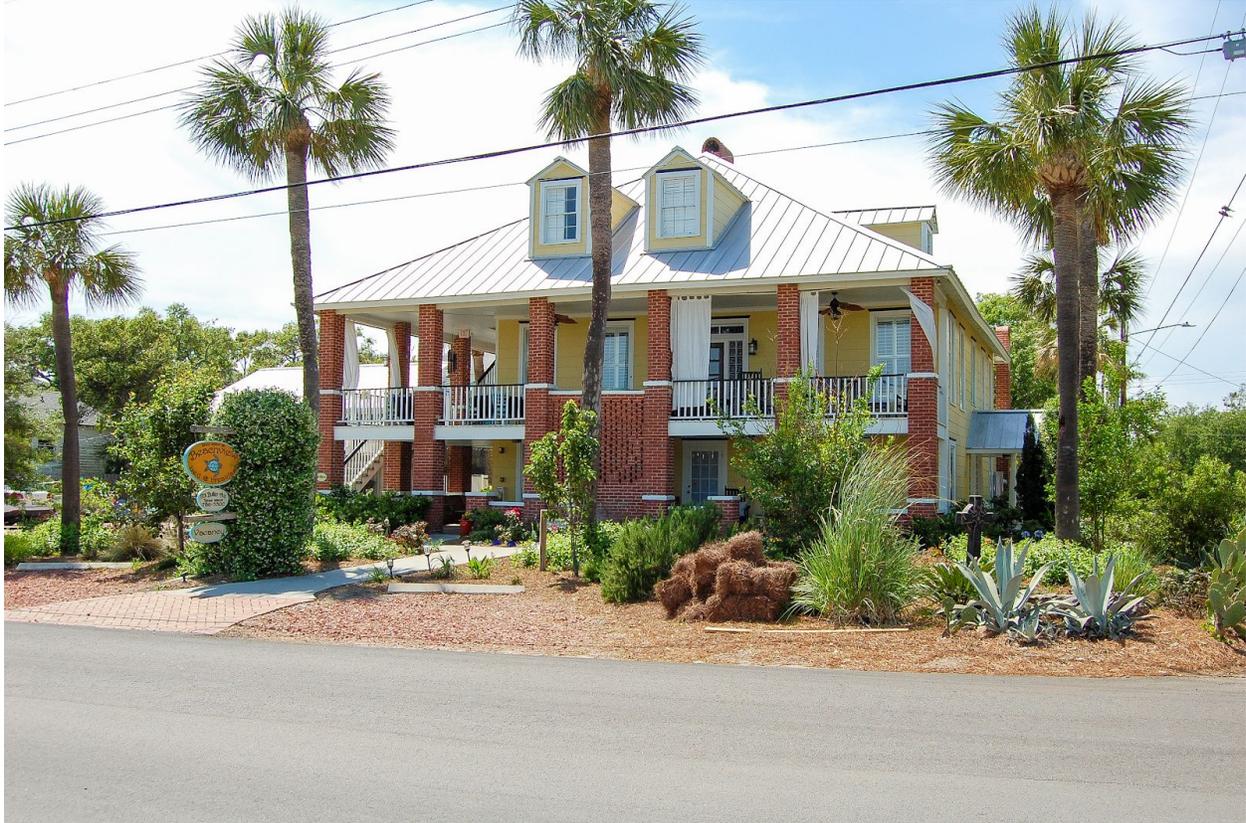
**Figure 17.** The Beachview Bed & Breakfast (Hunter House) has a wrap-around porch that incorporates the southeast corner of the house, the entirety of which is set within the recesses of the house’s pyramidal roof.

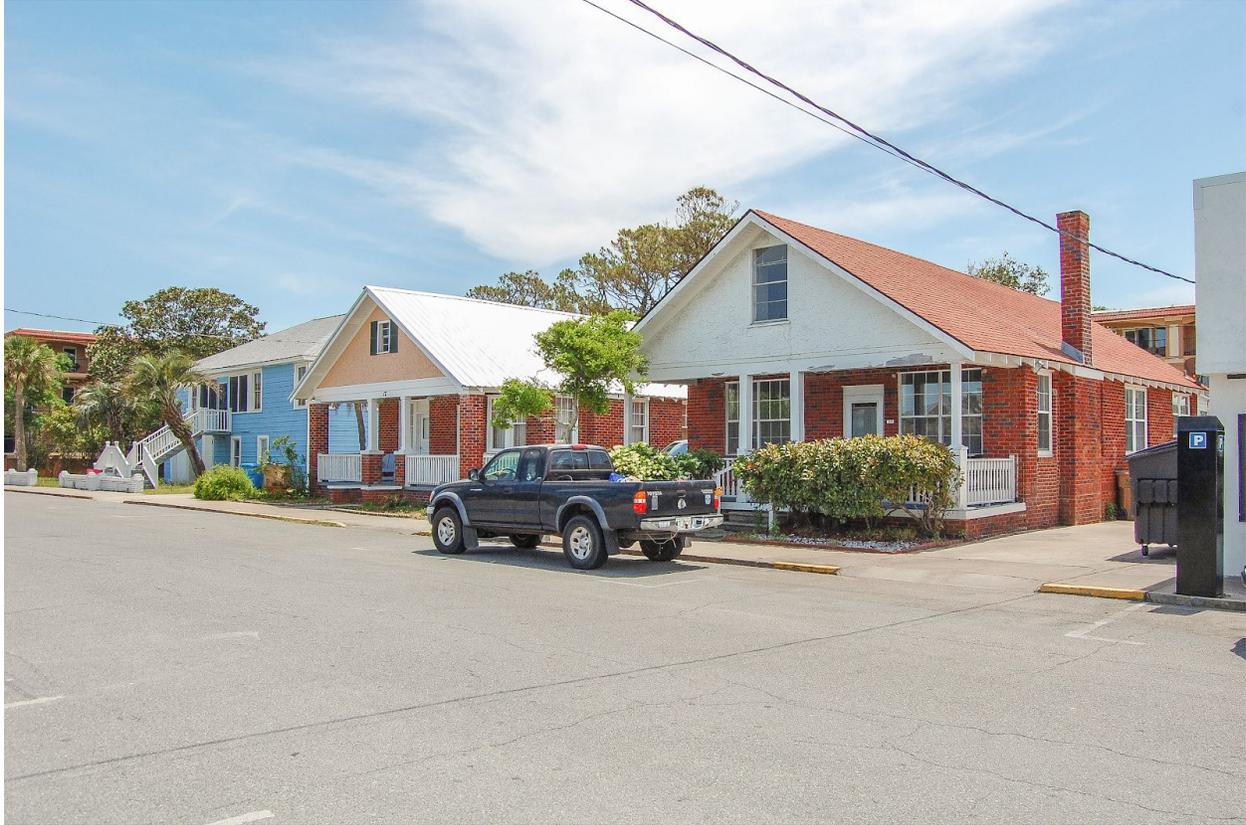
**Figure 18.** A common use of a full-width recessed porch in the South End, pictured here is the south side of 15th Street.

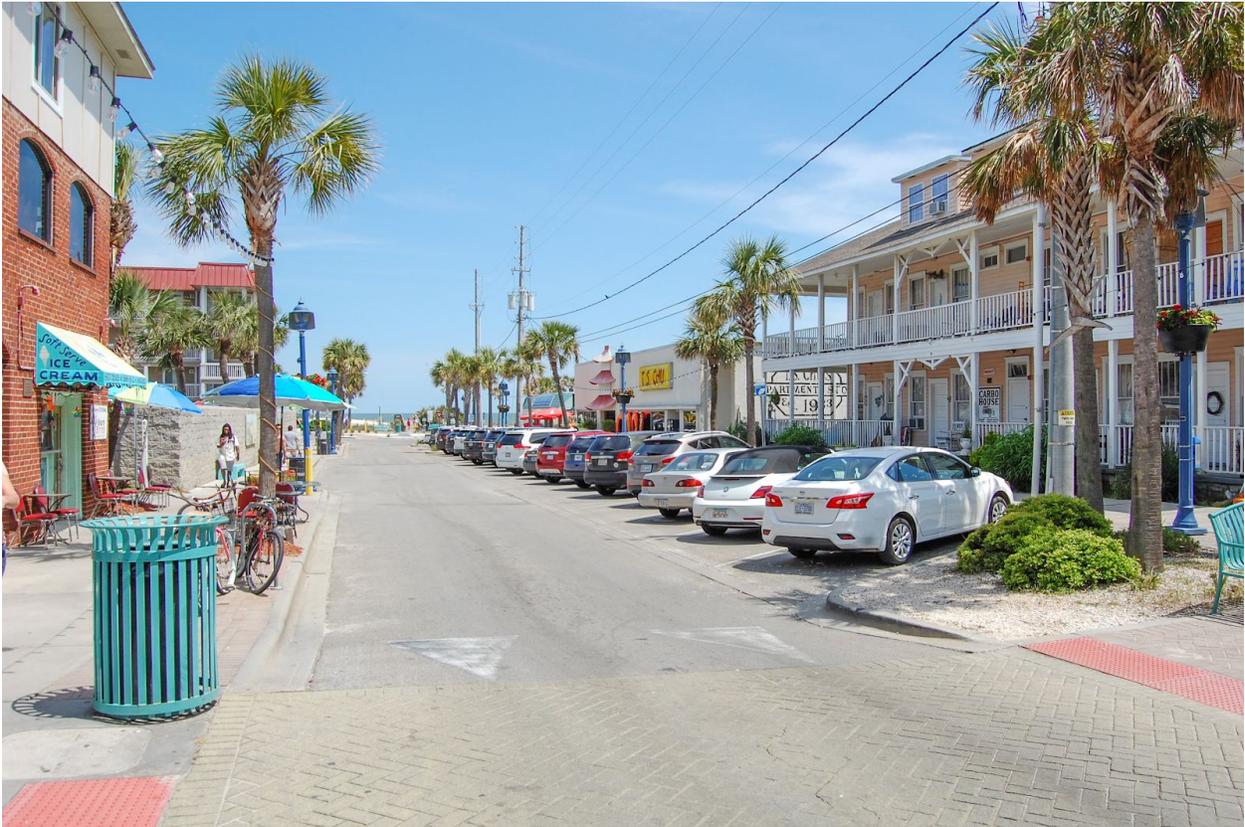
**Figure 19.** Looking east on Tybrisa Street with pedestrian street crossing pavement, streetscape elements, lighting, and landscaping visible.

Human-scale elements such as sidewalks, street trees, street lights, benches, and trash cans dot principal commercial streets, providing a framework for the pedestrian experience. Within these areas, concrete sidewalks and curbs, palm trees, and metal street furniture including lamp posts, trash cans, and benches exist, all of which are painted blue or teal. Additional landscaping includes bushes, pebble gravel, and hanging baskets from lamp posts. Further, festoon lights strung between these elements in separate strands on the north and south sides of the street are carried overhead down Tybrisa Street (Figure 19).

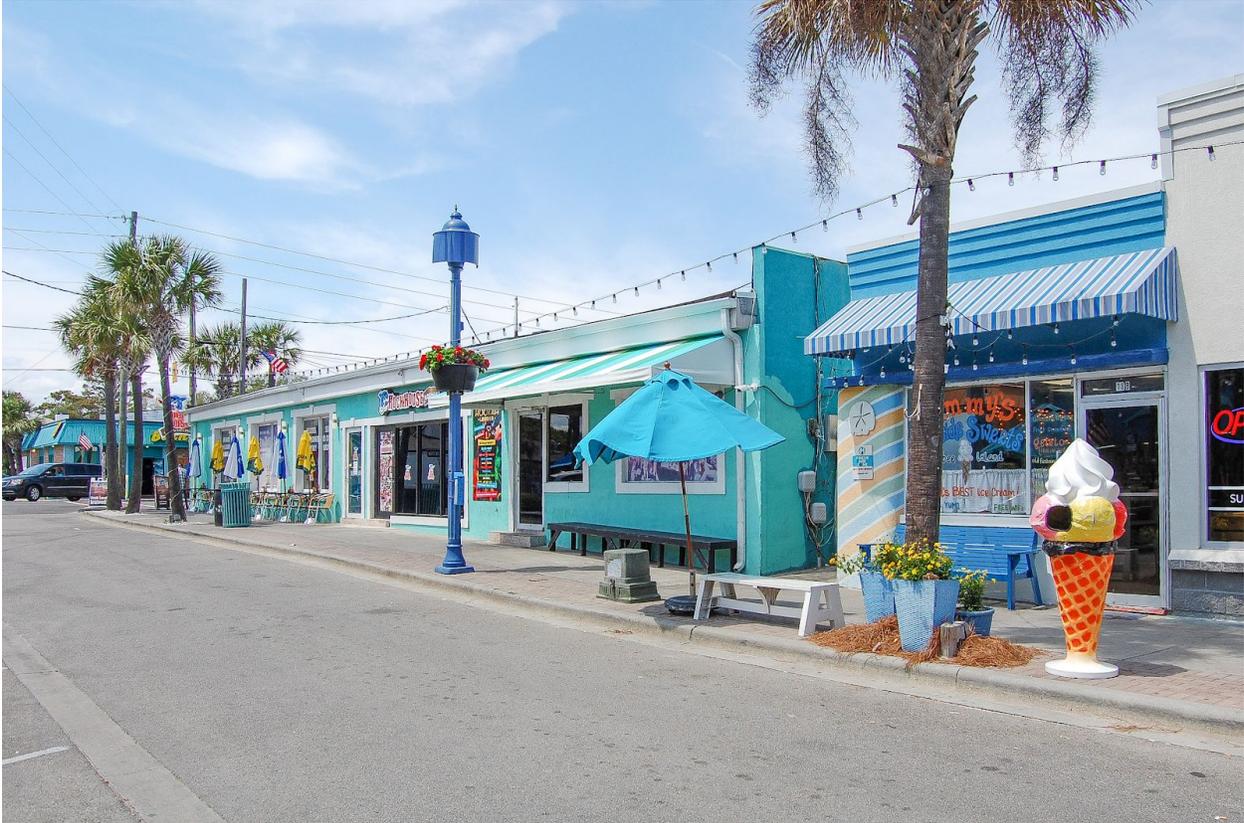
**Figure 20.** A display of fixed canopies (background) and awnings (foreground) used on Tybrisa Street in the South End, image looking northwest.

Awnings adorn the majority of commercial buildings within the overlay district (Figure 20). Characterized by bright colors, awnings provide covered entrance while adding visual interest. Within the South End, awnings exist in the form of an attached metal framework covered in fabric, but also in the form of a fixed canopy or permanent pent roof overhang. Although historically a form of signage, this has been discouraged in recent years due to the changing nature of business within the South End, necessitating the reuse of awnings.

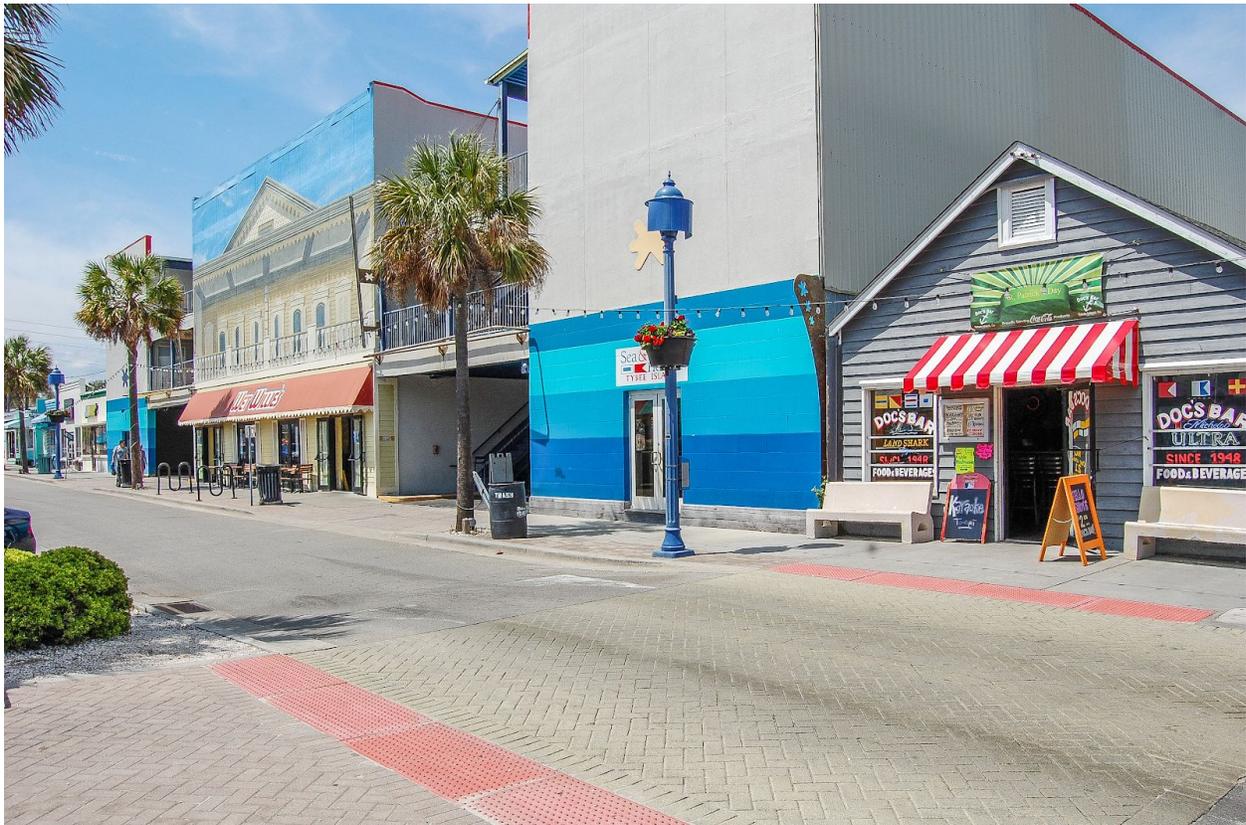
**Figure 21.** Photo showing the juxtaposition of new construction (left) at the Sea & Sand Hotel in concrete masonry units(CMU) and historic, frame construction (right) adjacent at Doc's Bar, image looking northwest.

Secondary to wood, concrete masonry unit (CMU) construction has likewise gained prominence (Figure 21). With early use beginning in the late 1920s, this is the second most common structural material within the South End. While some mid-century buildings feature concrete block as an exterior material, it is more commonly covered with stucco, siding, or brick. By far, CMU is the most used material for building foundations.

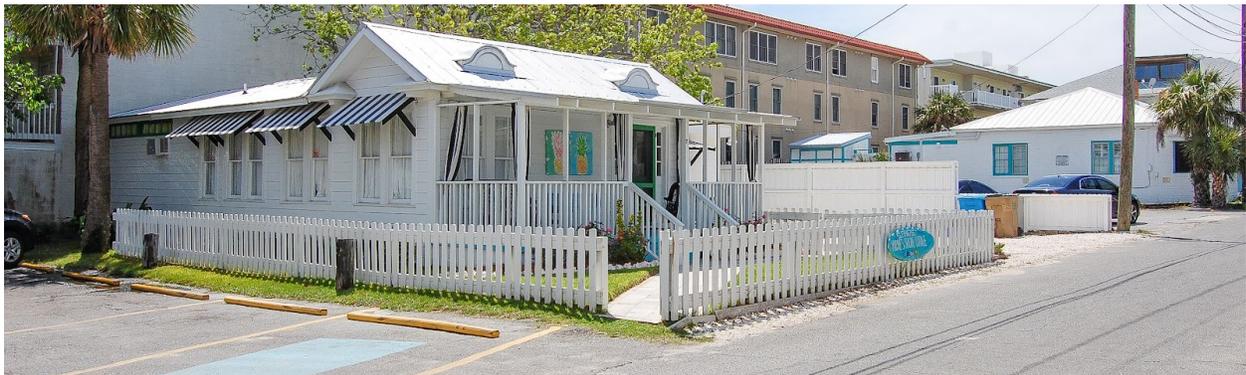
**Figure 22.** Photo of the south side of Izlar Street showing the use of two-over-two double hung sash windows (foreground) and six-over-six double-hung sash windows (background).

In every instance, doors and windows within South End are square in shape. The most common window type incorporated on residential buildings are double-hung sash windows, whereas commercial buildings most often incorporate fixed panes of storefront glass for display. Window pane configurations vary, however, two-over-two and six-over-six are common (Figure 22).

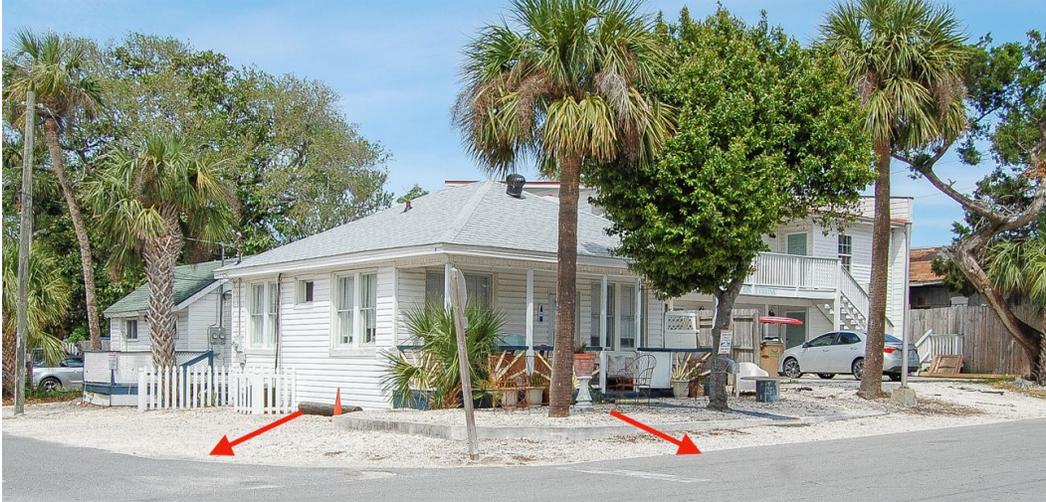
**Figure 24.** The grading surrounding this house at Tybrisa Street and Lovell Avenue is sloped, allowing water to shed away from the building.

Guideline 1.2 Grading surrounding a foundation should shed water away from the building (Figure 24).

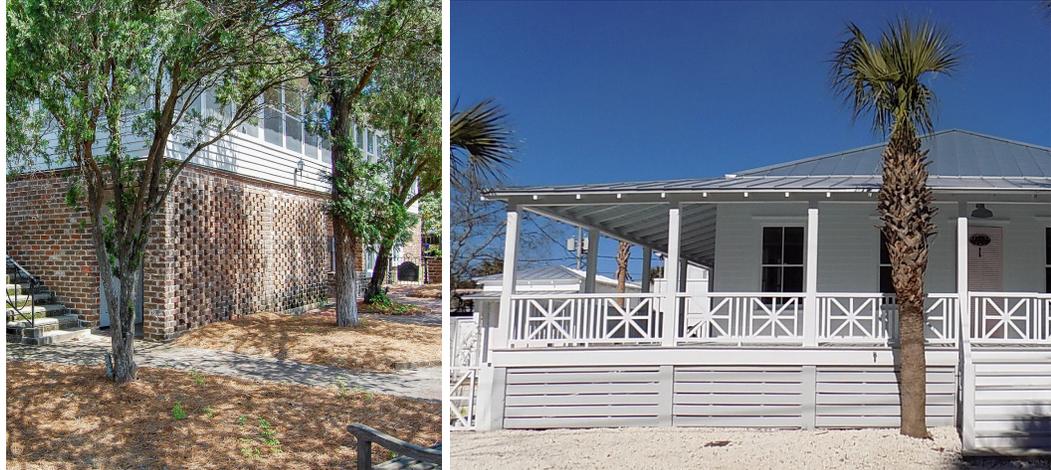
**Figures 25 (left) and 26 (right).** On the left, the brick piers of the house are interrupted by the staggered layering of bricks to allow for breathability. On the right, the use of hog pen boards that have been painted have been used to enclose the foundation and provide the passage of air.

Guideline 1.3 Foundation enclosure between piers may be acceptable if materials and methods used are reversible and allow for ventilation beneath the building (Figures 25 and 26).

- ◆ Preferred Method: Hog pen boards in wood that have been painted
- ◆ Secondary Method: Utilization of a material similar to the original foundation with new material recessed to emphasize the original piers
- ◆ NOT Recommended: The permanent enclosure or alteration of the design of the original porch or house foundation walls.

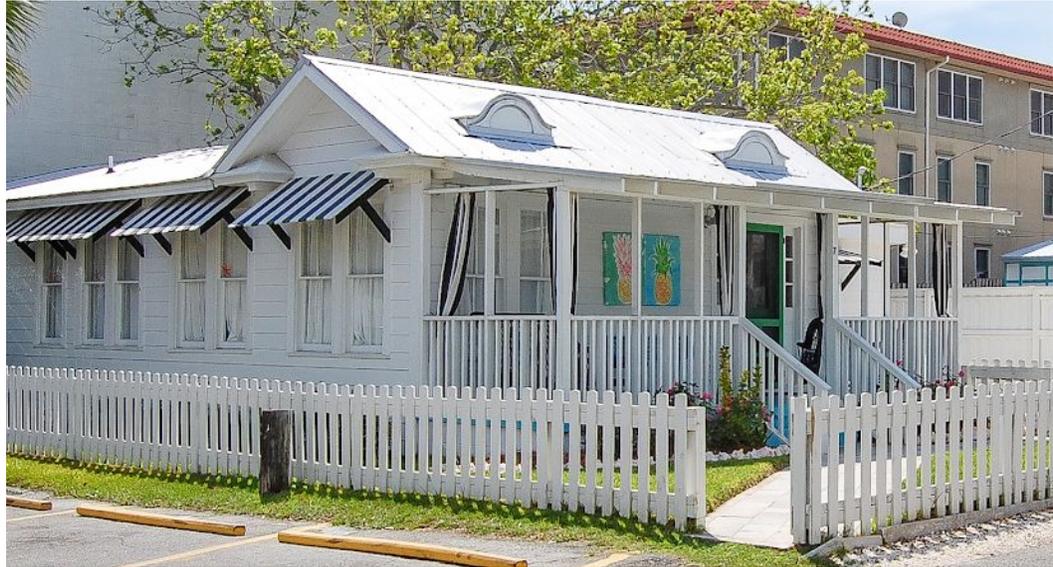
**Figure 27.** An example of historic woodworking that should be retained to include gable end returns, rafter end tails, and eyebrow dormers.

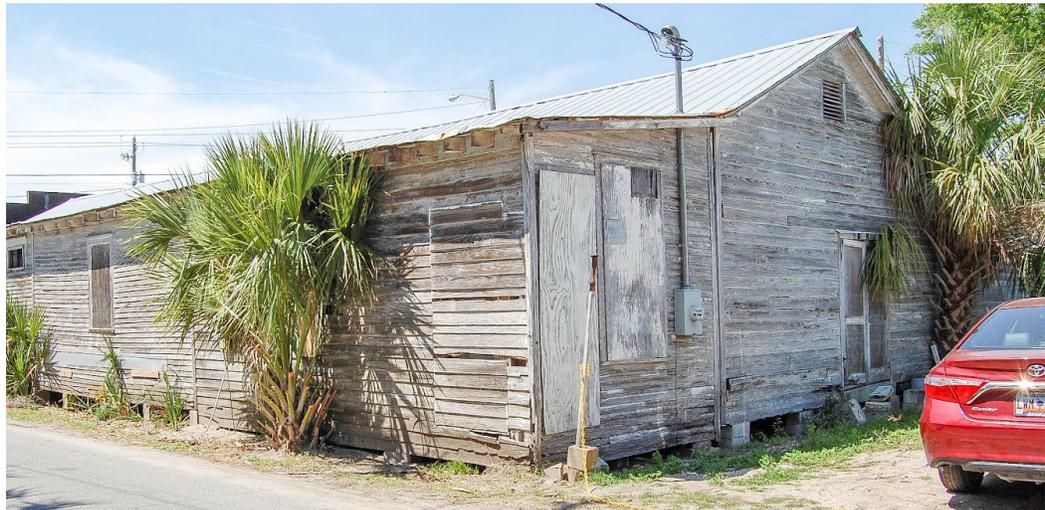
**Figure 28.** An example of detrimental vegetative growth that is dangerously close to this historic frame building on Izlar Street.

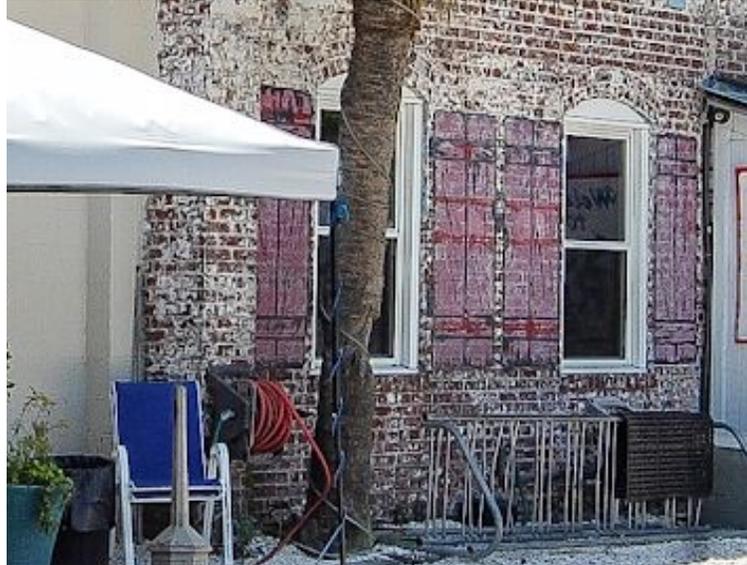
**Figure 29.** The application of paint and its subsequent removal has left this brick wall in an unnatural state, hiding the once exposed elliptical arches placed over these window openings.

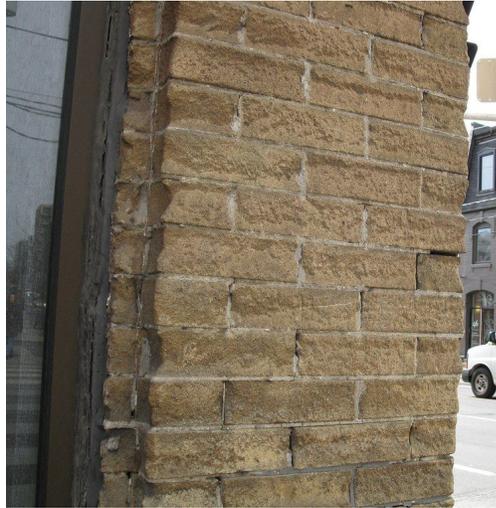
**Figure 30.** An example of brick that has been sandblasted in an effort to clean it and subsequently was damaged.

- ◆ NOT Recommended: The use of potentially damaging paint removal methods on wood surfaces, such as open-flame torches, orbital sanders, sandblasting, and caustic paint-removers (Figure 30).

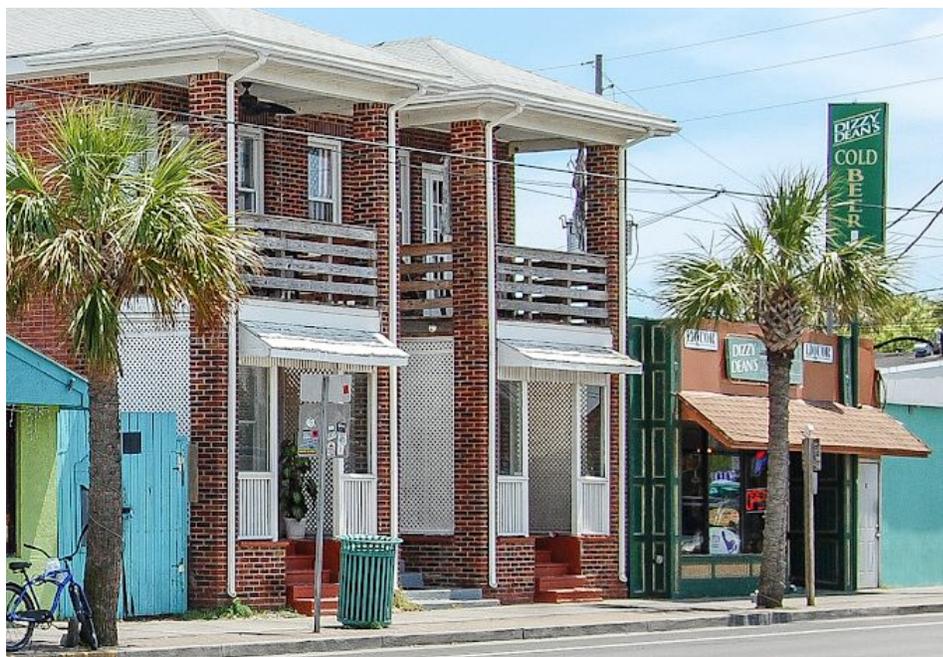
**Figure 31.** An example of first floor porch screening set within the columns of this two-story quadplex on Butler Avenue.

Guideline 4.3: Screening is recommended on the same or inner plane of columns and balustrades to retain the visibility of these character defining elements (Figure 31).

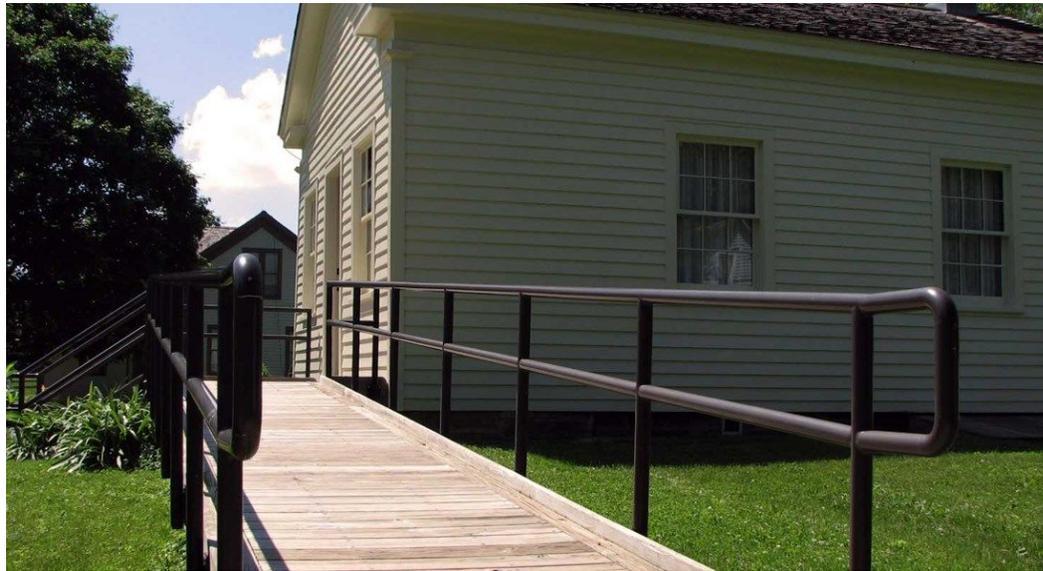
**Figure 32.** Example of a handicap accessible ramp that is not anchored to the historic building, however provides access.

Guideline 4.6: Ramps should be located to the side or rear of historic buildings, when feasible, and should not be anchored into the building (Figure 32).

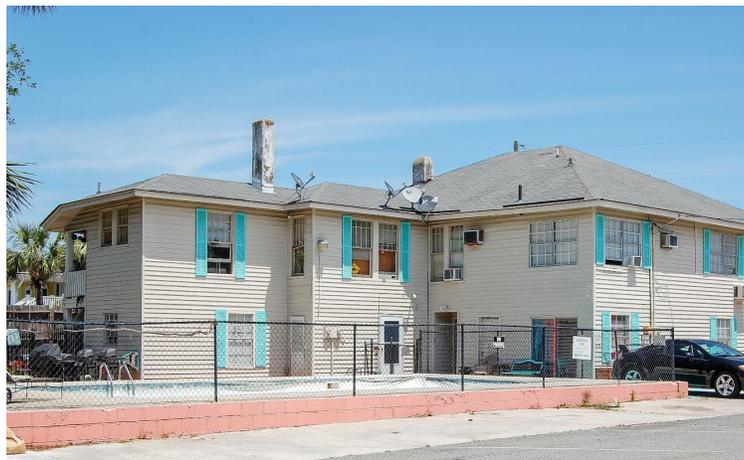
**Figure 33.** Example of a chain-link fence on 14th Street in South End. While it safely protects the in-ground swimming pool beyond, a more appropriate fence material adjacent to this frame dwelling would be a fence in wood.

Guideline 6.5: The use of chain-link fencing shall not be allowed (Figure 33).

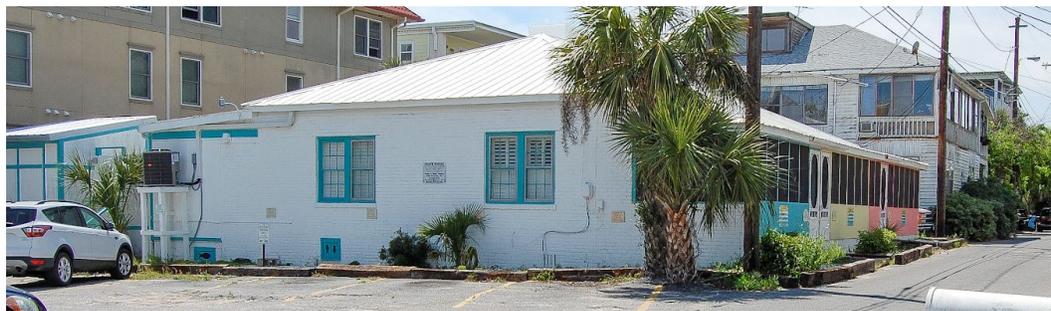
**Figure 34.** House on the south side of Izlar Street that incorporates an addition on the rear facade (left). By placing the addition at the rear of the property and setting its roofline and roof pitch below the primary roof of the house, it is diminutive and unimposing.

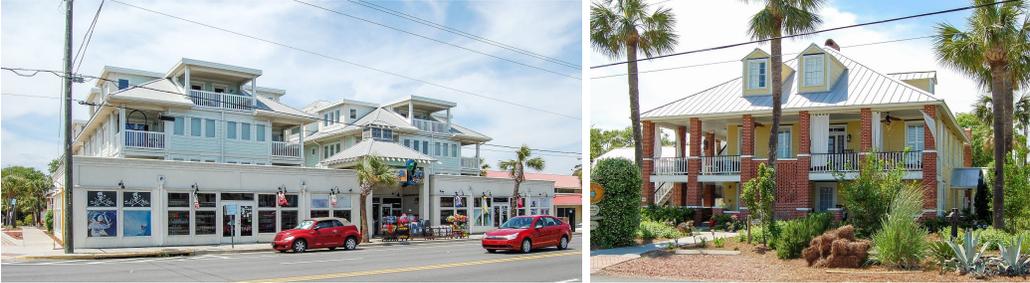
**Figures 35 (left) and 36 (right).** New Development on Butler Avenue is subdivided horizontally between floors and vertically in the center (left). Traditionally raised cottages have a base foundation, middle living section, and floor within the roof structure (right).

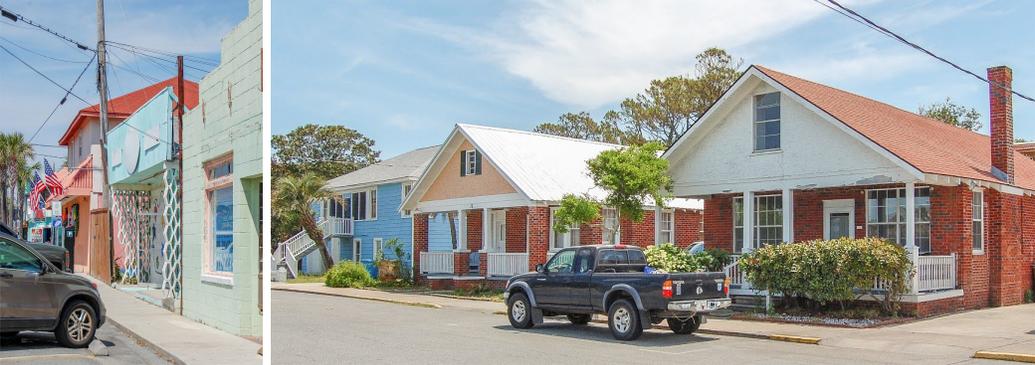
**Figures 37 (left) and 38 (right).** Consistent storefronts on Butler Avenue create continuity along the commercial street (left). Regular setbacks and spacing on 14th Street create a harmonious rhythm along the street (right).

Guideline 1.3: Building setback should be the average setback for the buildings on the block front where the building will be placed, unless the average historic building setback on the block front where the building will be placed is greater. In this instance, the building setback should be placed at the average historic setback. (Figures 37 and 38).

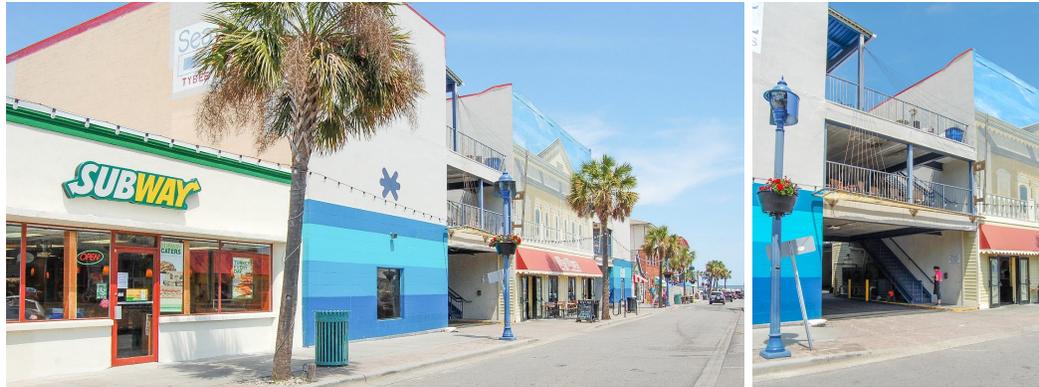
**Figures 39 (left) and 40 (right).** Consistent storefronts on Tybrisa Street are broken with a driveway disrupting the sidewalk and pedestrian flow of traffic.

Guideline 1.4: Block fronts on principal commercial streets should not be interrupted by automobile access, driveways, or drop-off areas. These features allow cars to travel into and over pedestrian sidewalks negatively impacting the walkability of main street. (Figures 39 and 40).

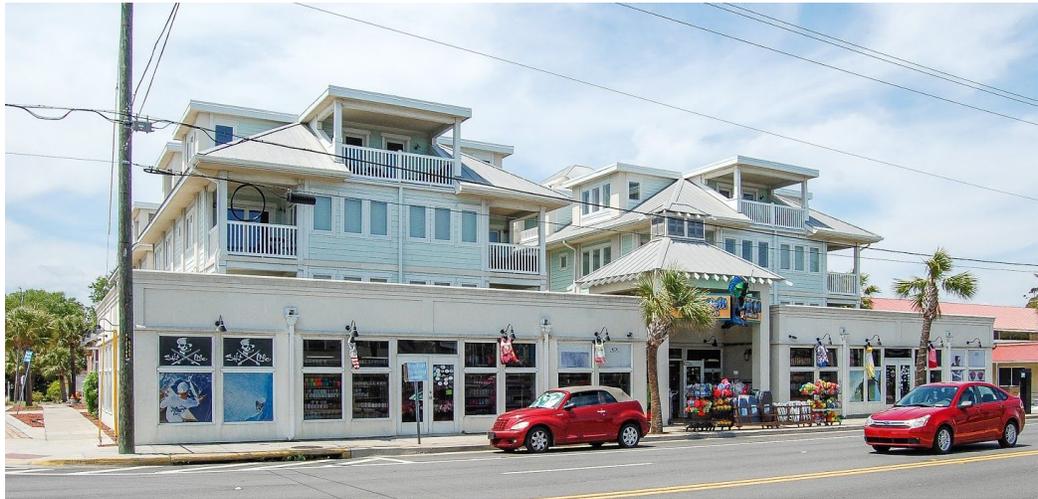
**Figure 41.** This development along Butler Avenue incorporates retail uses on the ground floor creating an active pedestrian sidewalk. Residential uses are in the floors above. The first floor is designed as a storefront with over 50% glazing while upper floors have glazing (openings) on over 25% of the facade.

Guideline 3.1: First floors of buildings should incorporate street facing active uses (including but not limited to retail, office, lobby, restaurants, hotels, and inns) that span the length of the façade on all facades fronting principal commercial streets and maintain individual primary exterior entrances. (Figure 41).

Guideline 5.1: The first story of a commercial building should be designed as a storefront on principal commercial streets. First floor retail storefront area glazing should not be less than 55 percent. Glazing should be transparent (Figures 41, 44, and 45).
