# DESIGN GUIDELINES MANUAL

### SOUTH END BUSINESS OVERLAY DISTRICT

The City of Tybee Island  
Chatham County, Georgia

September 2019

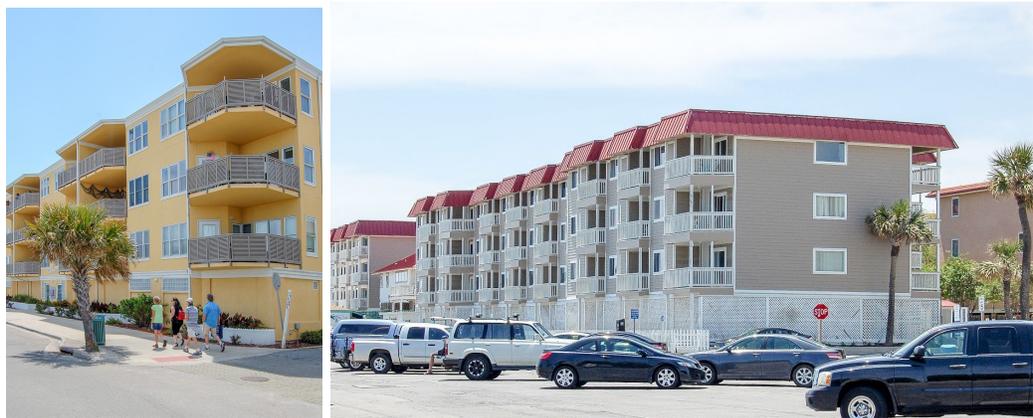
**Figures 42 (left) and 43 (right).** Enclosed parking on a major commercial corner limits commercial and pedestrian opportunities (left). Podium parking at the ground floor is limited to users of the building and when coupled next to a surface lot, can result in large sections of inactivity with the central business district (right).

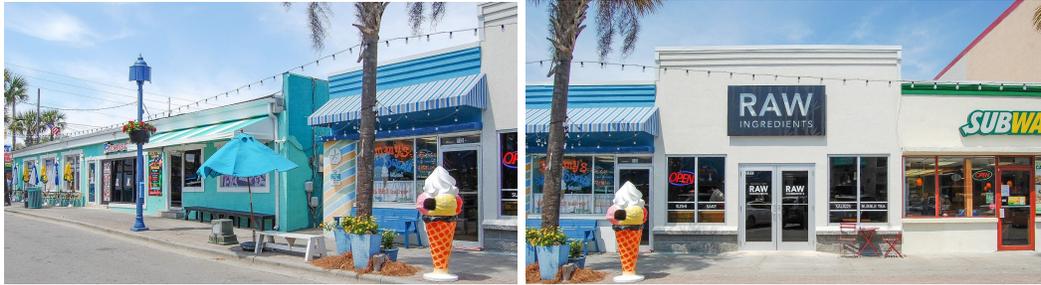
**Figures 44 (left) and 45 (right).** First floor storefronts line both sides of Tybrisa Street, a principal commercial Street.

Guideline 5.1: The first story of a commercial building should be designed as a storefront on principal commercial streets. First floor retail storefront area glazing should not be less than 55 percent. Glazing should be transparent (Figures 41, 44, and 45).

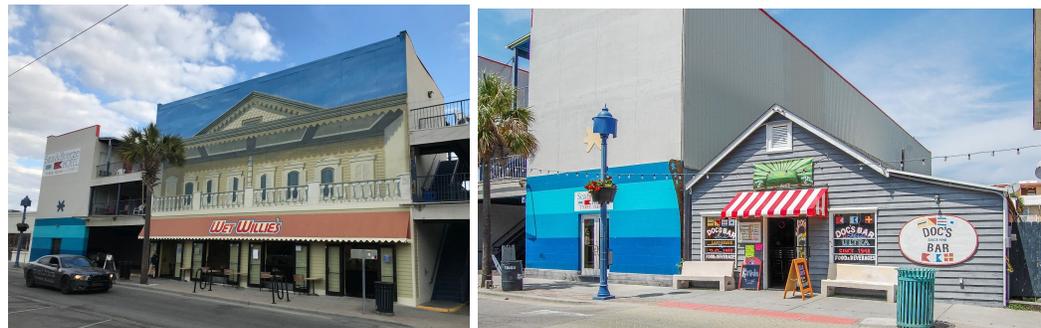
**Figures 46 and 47.** Solid upper walls with no openings create the appearance of larger massing out of scale with historic buildings along Tybrisa Street; albeit this creative approach used a mural to simulate a more compatible openings and roof on the upper floors.

Guideline 5.3: For each floor above the first floor, building walls should incorporate openings at a minimum of 25 percent of the wall face (Figures 46 and 47).

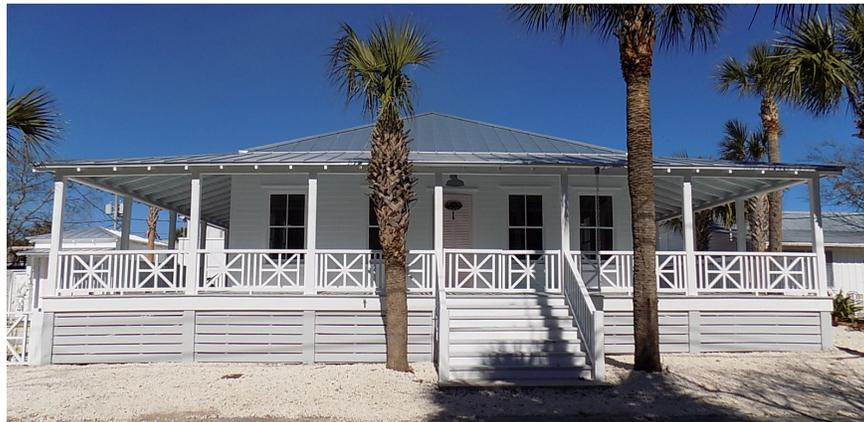
**Figure 48.** A large wrap-around porch at 16 Izlar Avenue breaks-up the building mass with a transitional feature between the solid building wall and the exterior public realm. Enclosures are located at the rear, not readily visible from the street view.

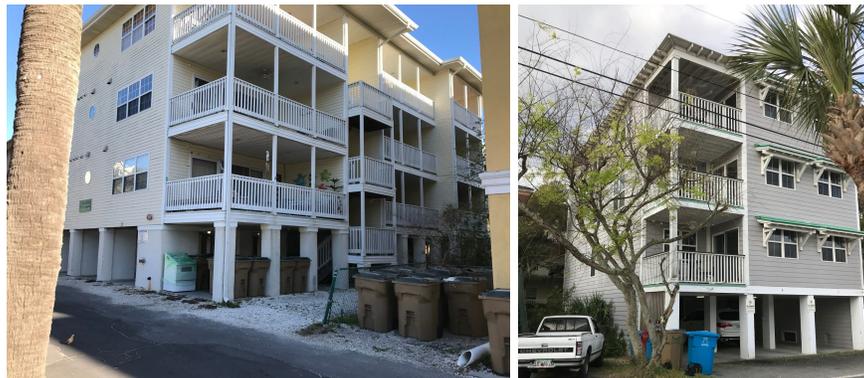
**Figures 49 (left) and 50 (right).** Newer development on Izlar Avenue uses porches for each unit facing the street which provides access to the exterior and breaks-up the building mass with a transitional and transparent feature between the solid wall and the exterior. These examples illustrate the use of columns and railings to separate the feature from the main building mass.

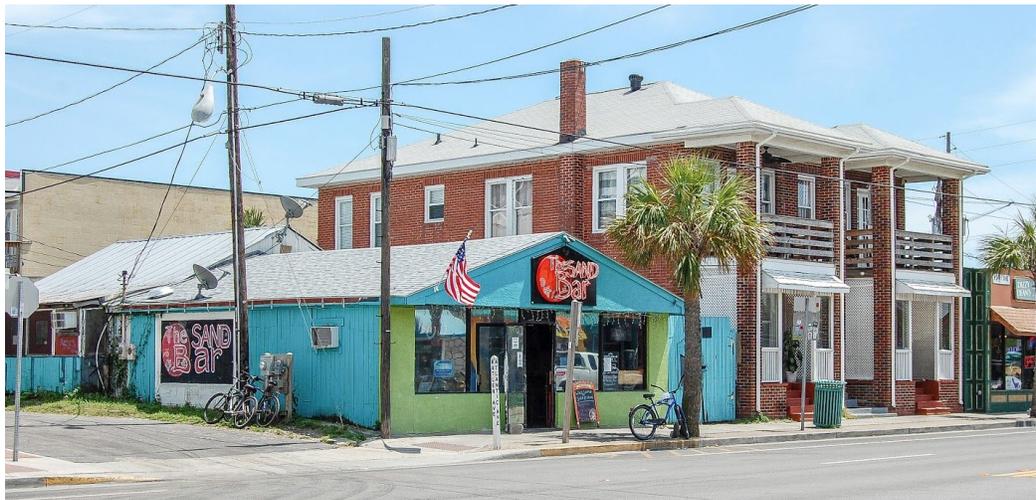
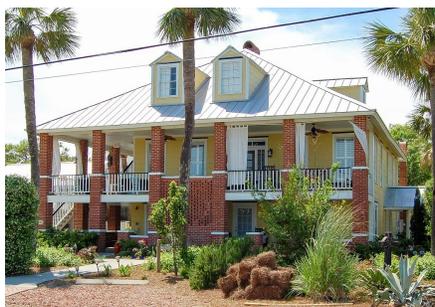
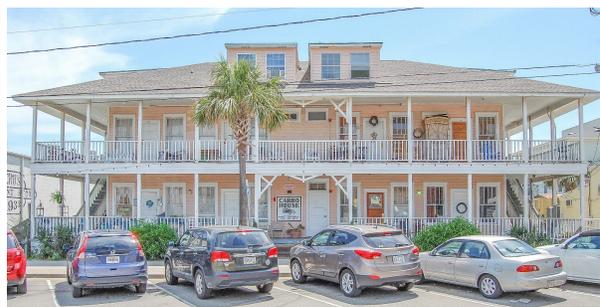
**Figures 51 (top), 52 (left), and 53 (right).** These images of two- and three-story buildings along Butler Avenue and Tybrisa Street illustrate how the use of a pitched roof (along with porches) helps to break up the otherwise rectangular building mass.

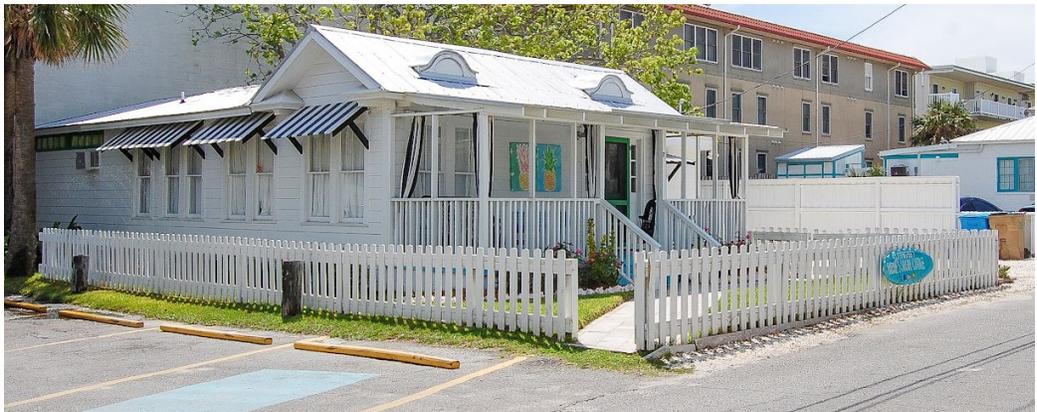
**Figure 54.** This cottage on Izlar Avenue illustrates a three foot tall fence in the front and side yards, allowing visibility of the building while clearly outlining the private front yard. The fence is painted wood matching the material and finish treatment of the house that it is associated with.

Guideline 8.2: Within the front yard setback, the height of any fence or wall should not exceed three (3) feet. (Figure 54).

Guideline 8.4: Fence and wall materials should be compatible and consistent with the primary structure to which they are associated. (Figure 54).

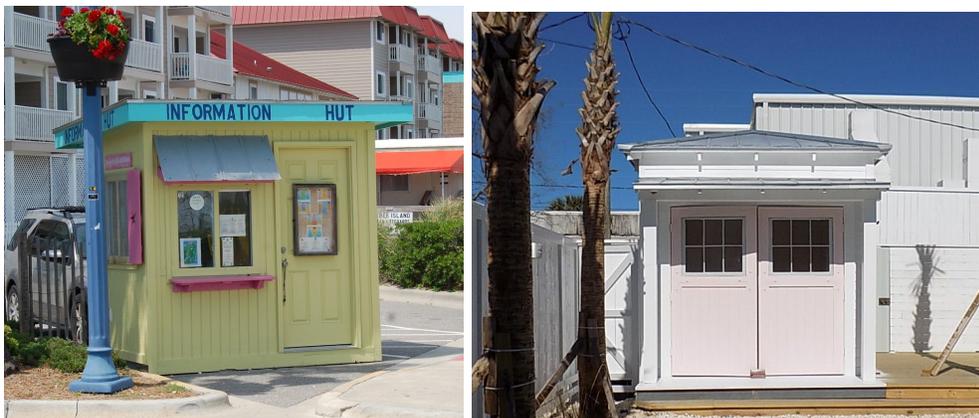
**Figures 55 (left) and 56 (right).** Outbuildings or secondary structures in the district are not common. These two show compatible wood building material, secondary massing and scale that is subordinate to principal buildings.

Guideline 10.1: Accessory buildings should be secondary in height, scale, and mass to the principal structure to which they are associated. (Figures 55 and 56).

Guideline 10.2: Accessory buildings should correspond in material and detail to the principal structure to which they are associated. (Figures 55 and 56).
